In accordance with our approved October 21, 2014 scope of services document, the Whitman, Requardt & Associates, LLP (WRA) team has prepared this Design Level Inspection Report to present our findings (with repair recommendations and conceptual costs) resulting from the recently completed design level inspection and testing of the specified project bridges, which include the following:

The Wilmington Viaduct consists of Bridges 1-748, 1-748N, and 1-748S and comprises the mainline elevated section of I-95 in downtown Wilmington, Delaware over Amtrak and various City streets. The entire structure is a sixty (60) span steel beam bridge composed entirely of single span units built in 1964 and widened in 1978. Rehabilitation was performed on the viaduct in 2000 that included bearing replacements, seismic retrofits, strip seal replacements, parapet rehabilitation, substructure repairs, drainage repairs, and painting. The viaduct has an overall length of 5462'-0"± measured from centerline of abutment bearings.

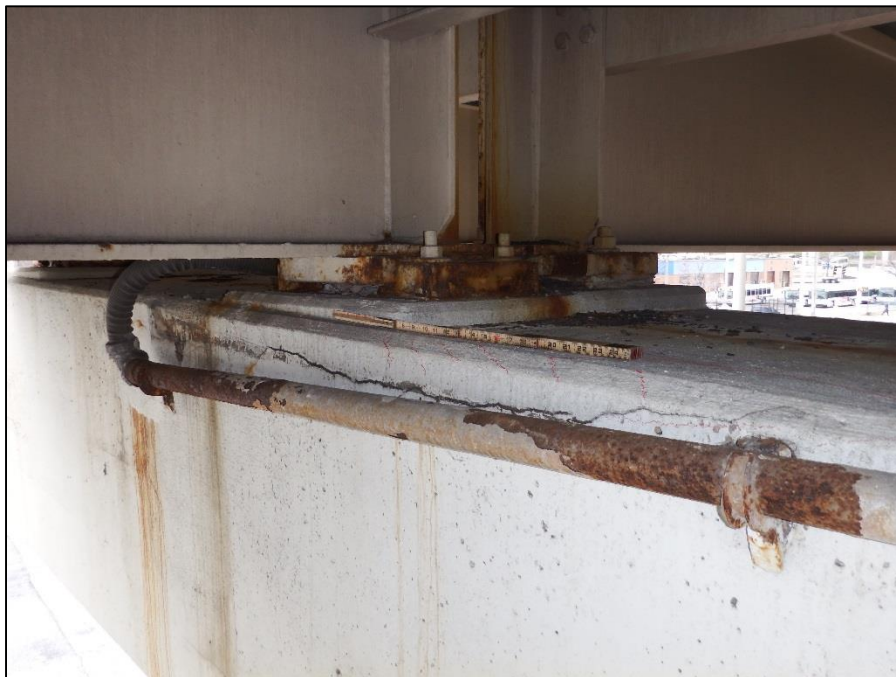
Photo 4: Delamination with up to 1/4" wide perimeter cracking (Pier 6, east face of cap below Beam 5)

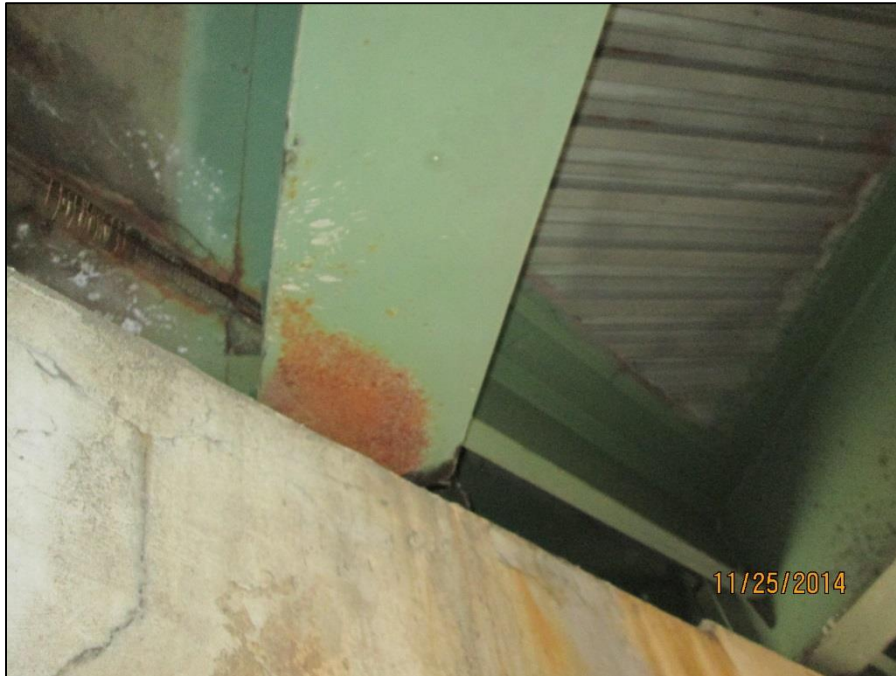
Photo 1: Typical beam end paint condition (Beam 8, Span 1 at Pier 1 shown)

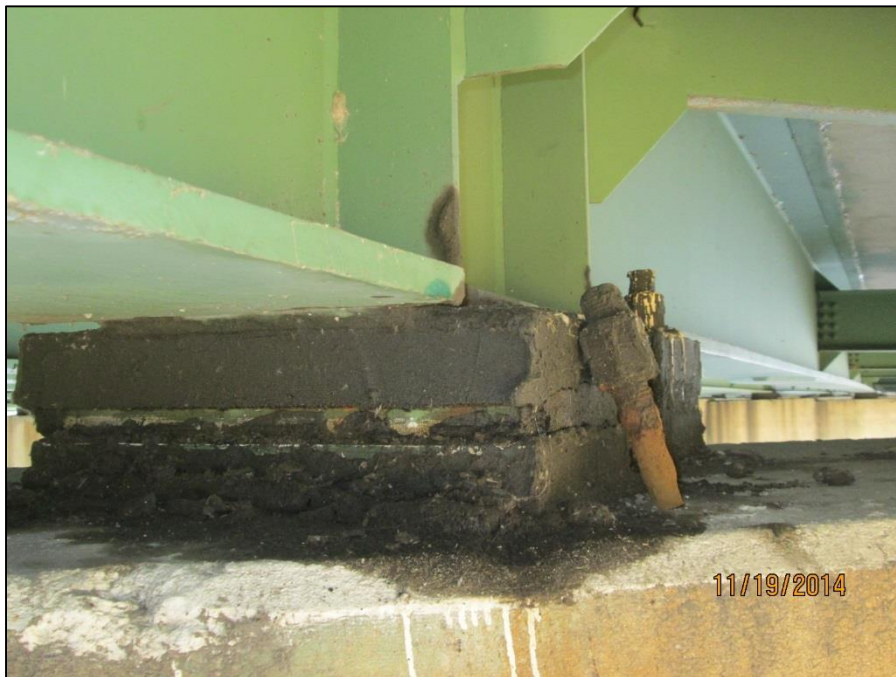
Photo 2: Typical Sheared Anchor Bolt (Bearing 1 at Pier 5, Span 6 Shown)

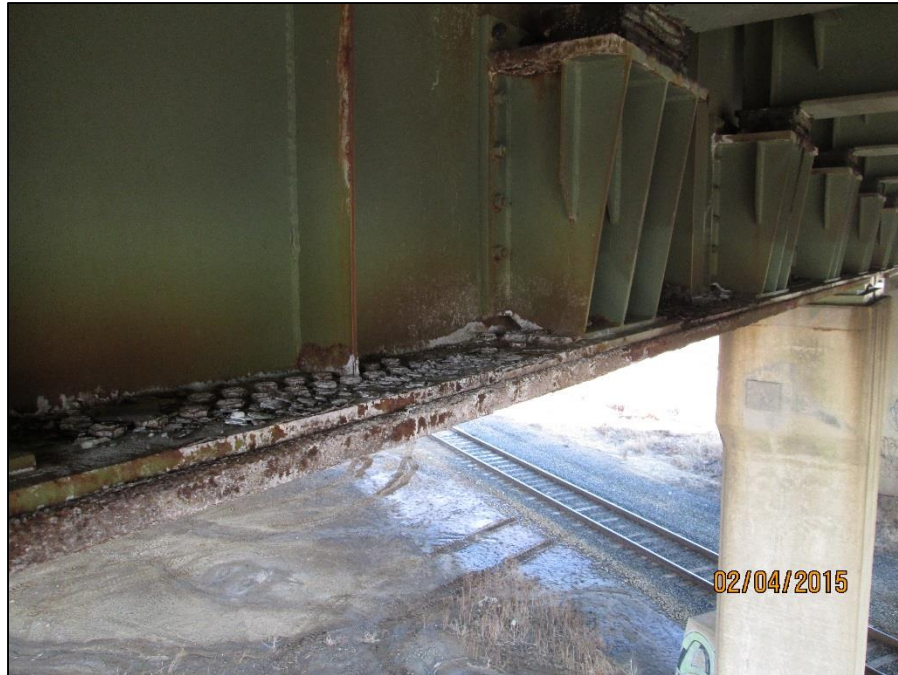
Photo 3: Typical heavy rust and delamination of the pier caps (Pier 4, Span 4 shown)

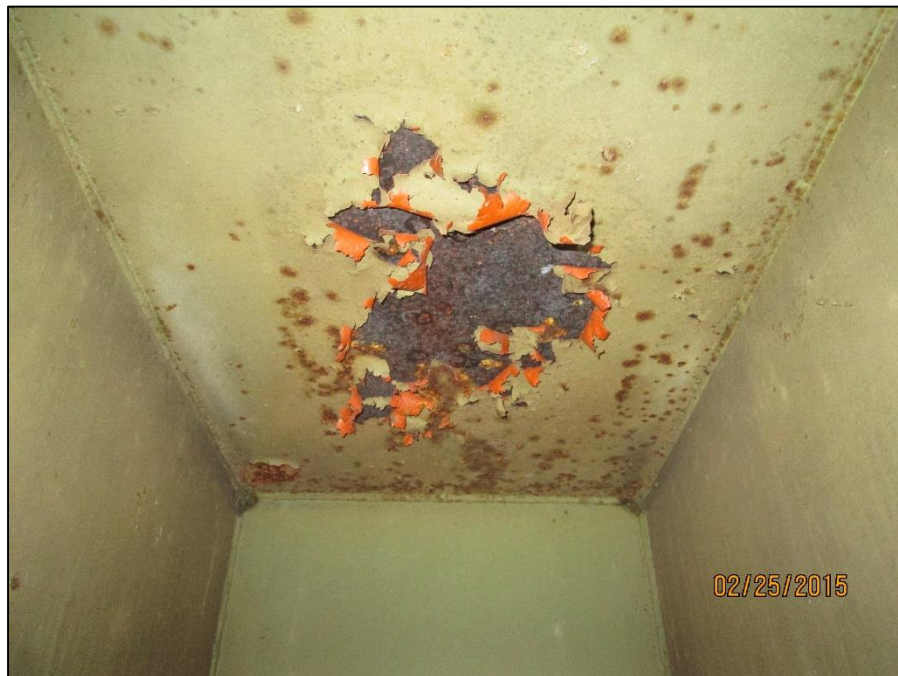
Photo 4: Typical peeling paint inside the pier caps (Pier 1 Cap, Bay 10 shown)

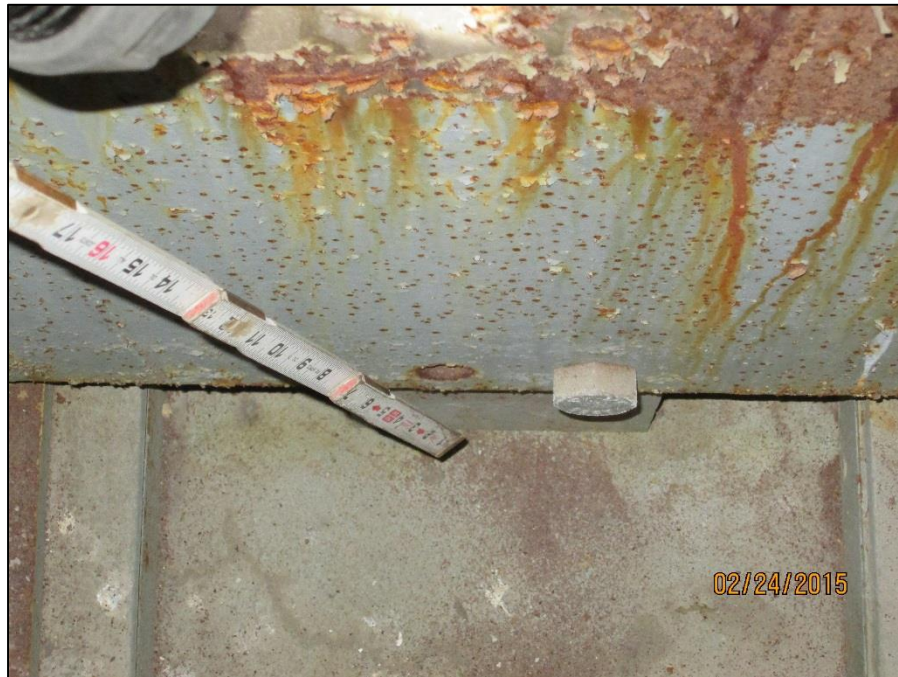
Photo 5: Missing bolt on the east side of the west full height diaphragm, Pier 3 Cap, Bay 9

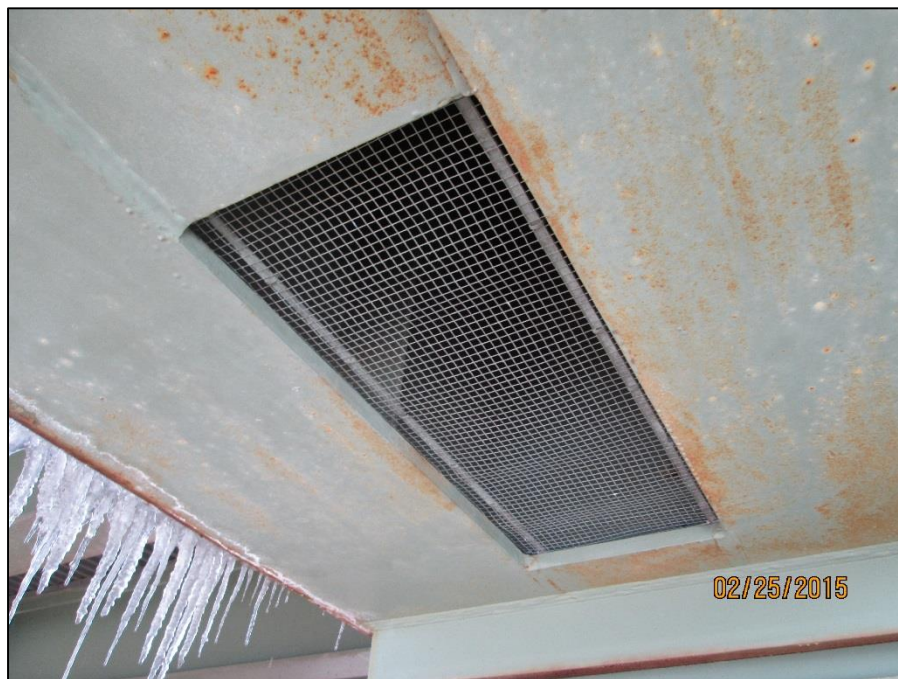
Photo 6: Typical broken access grate (Pier 4 Cap, West Overhang shown)

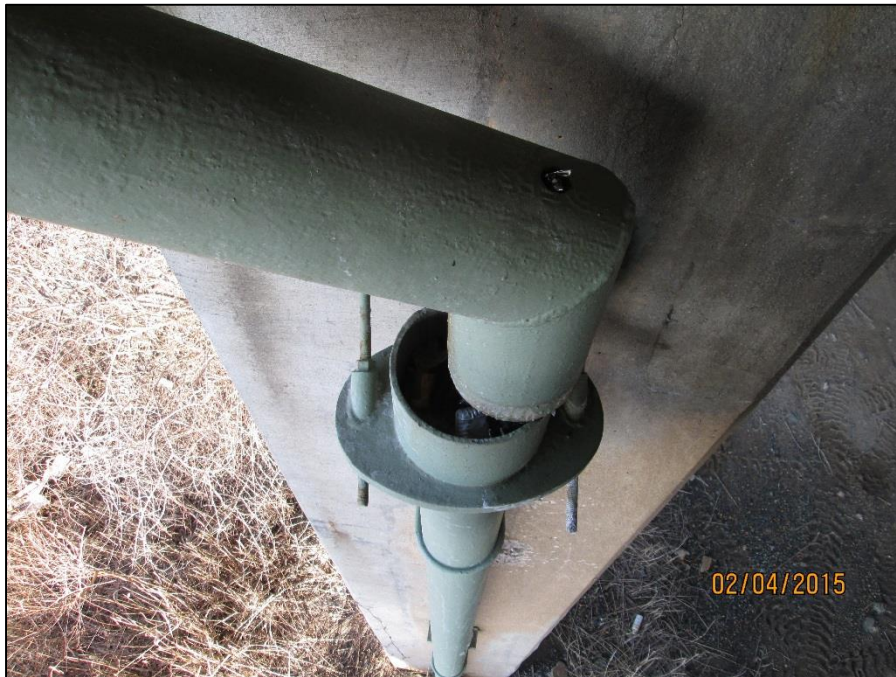
Photo 7: Disconnected and clogged drain pipe (Pier 4, Column 1 shown)

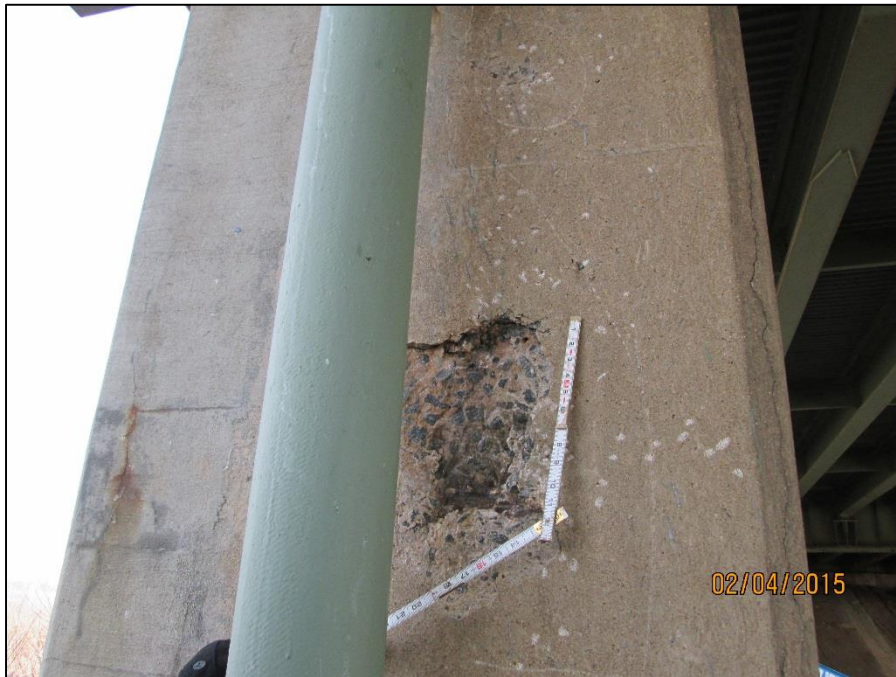
Photo 8: Typical spall at column (Pier 4, Column 1, South Face shown)

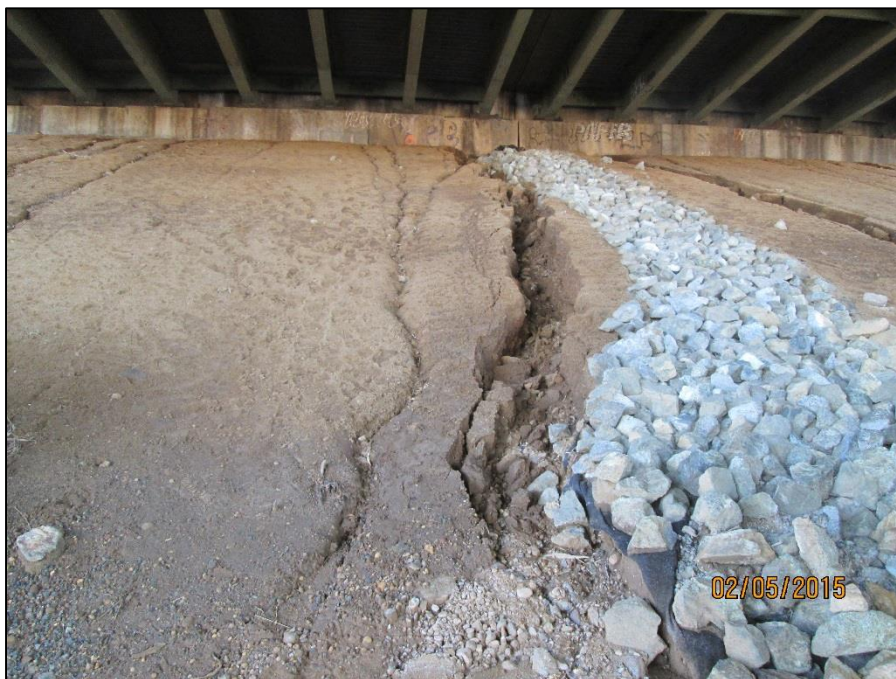
Photo 9: South Abutment Slope Erosion

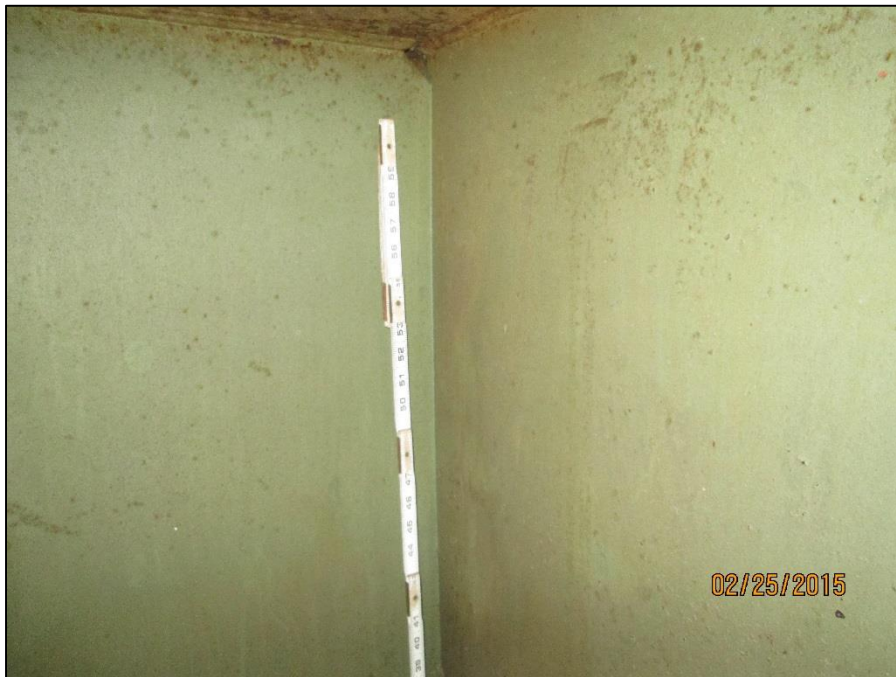
Photo 11: Missing vertical weld, Pier 4 Cap, Bay 13

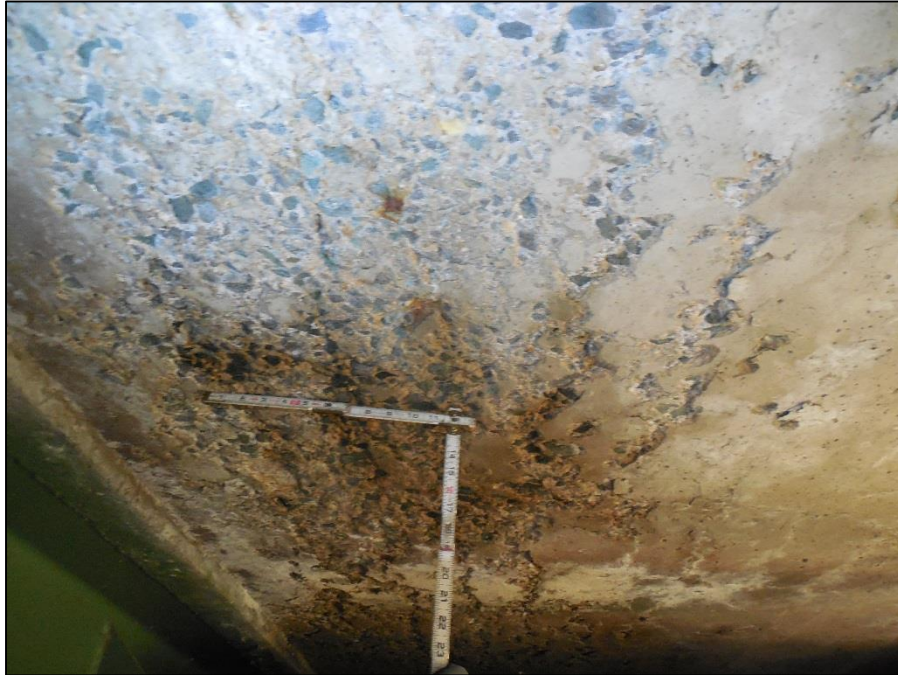
Photo 1: Poor consolidation of concrete on underside of deck (Span 3, Bay 4 shown)

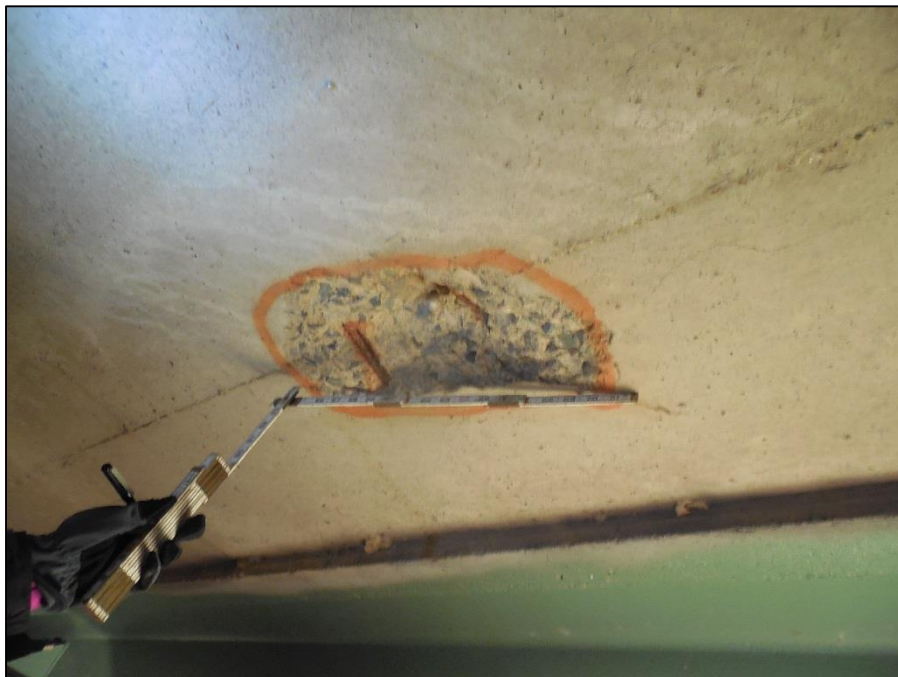
Photo 2: Typical local spalls with exposed rebar in the underside of the deck (Span 1, Bay 4 shown)

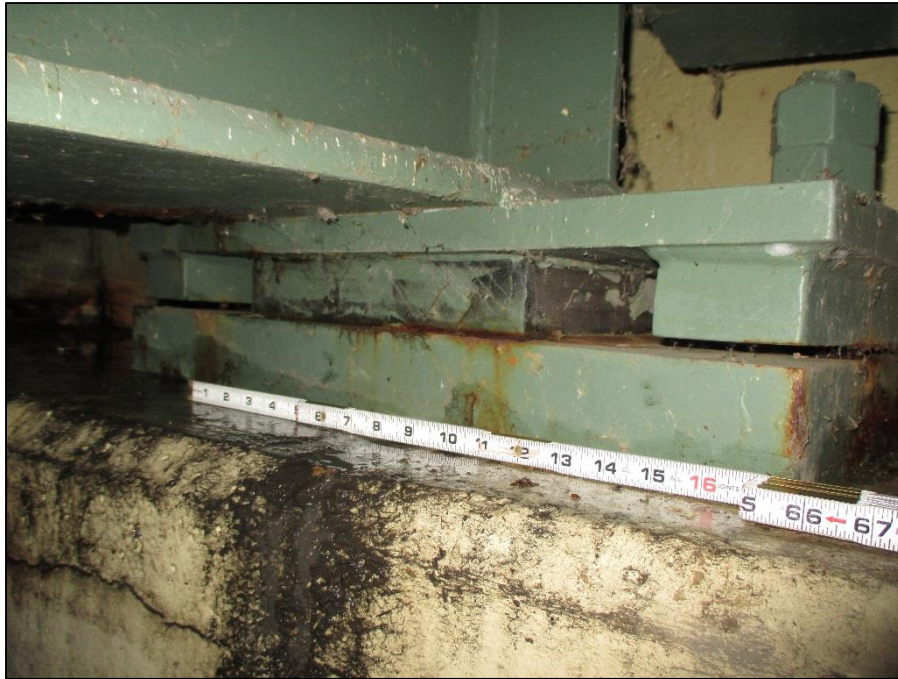
Photo 3: Typical bearing with areas of rust (South Abutment, Bearing 4 shown)

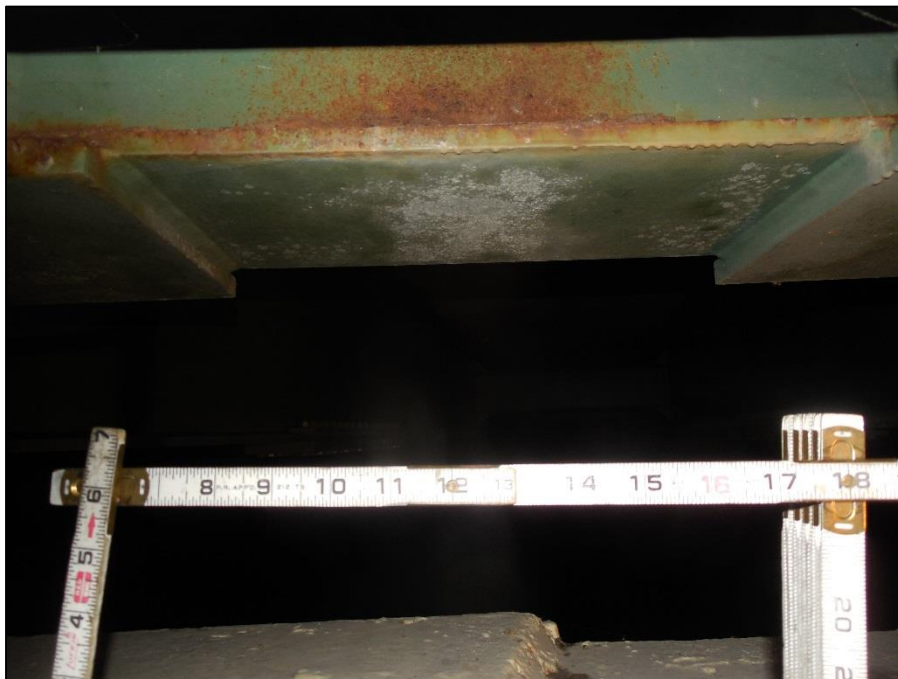
Photo 4: Typical localized paint rusting and chalking (Span 1, Pier 1, Bay 4 end diaphragm shown)

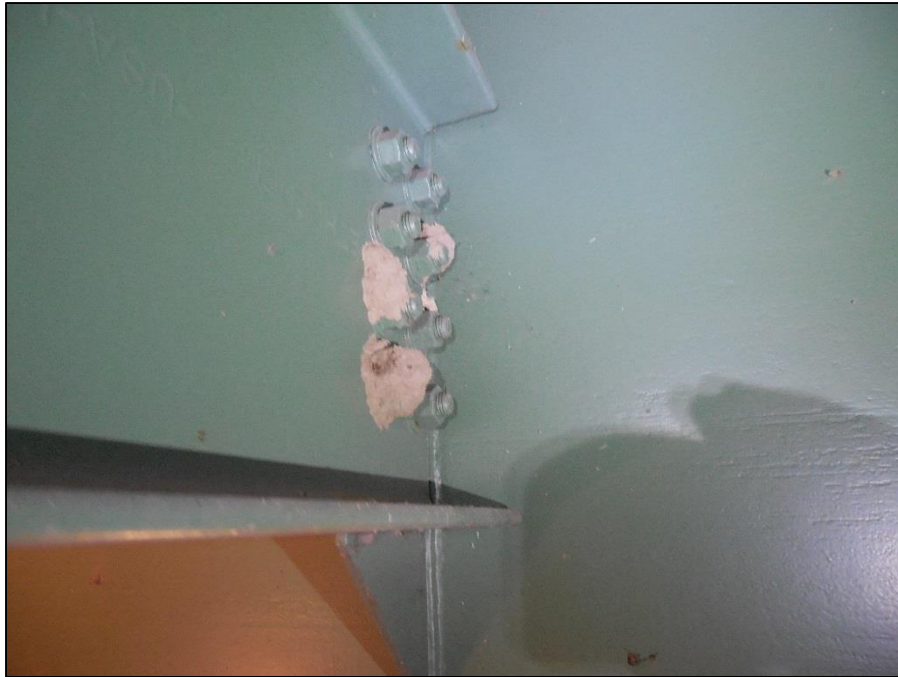
Photo 5: Typical insect hives throughout superstructure (Span 3, Bay 3 shown)

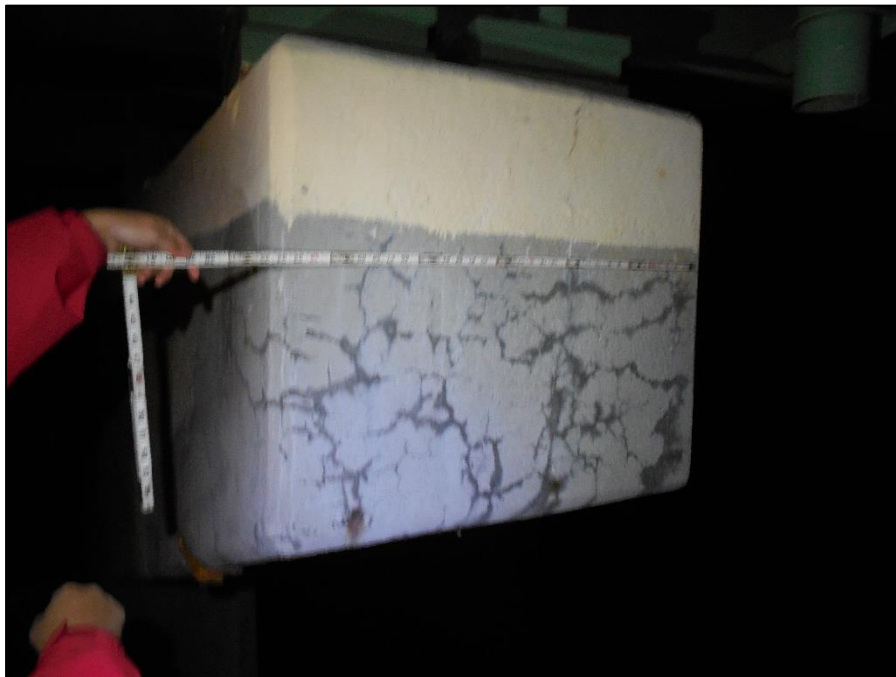
Photo 8: Map cracking on substructure (Span 3, Pier 2, west hammerhead shown)

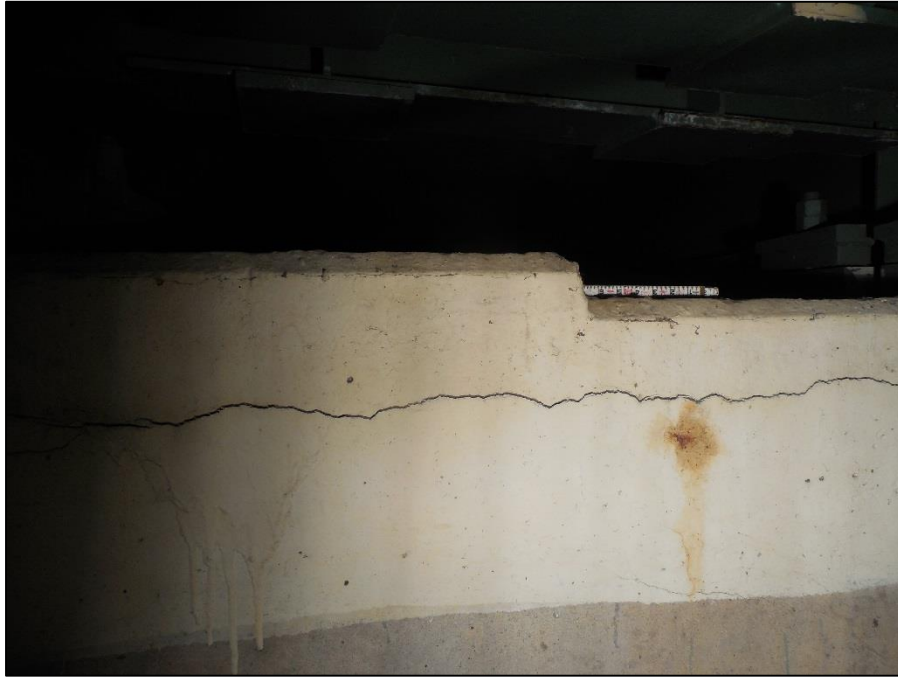
Photo 9: Typical horizontal 1/16" crack in pier cap (Span 2, Pier 2)

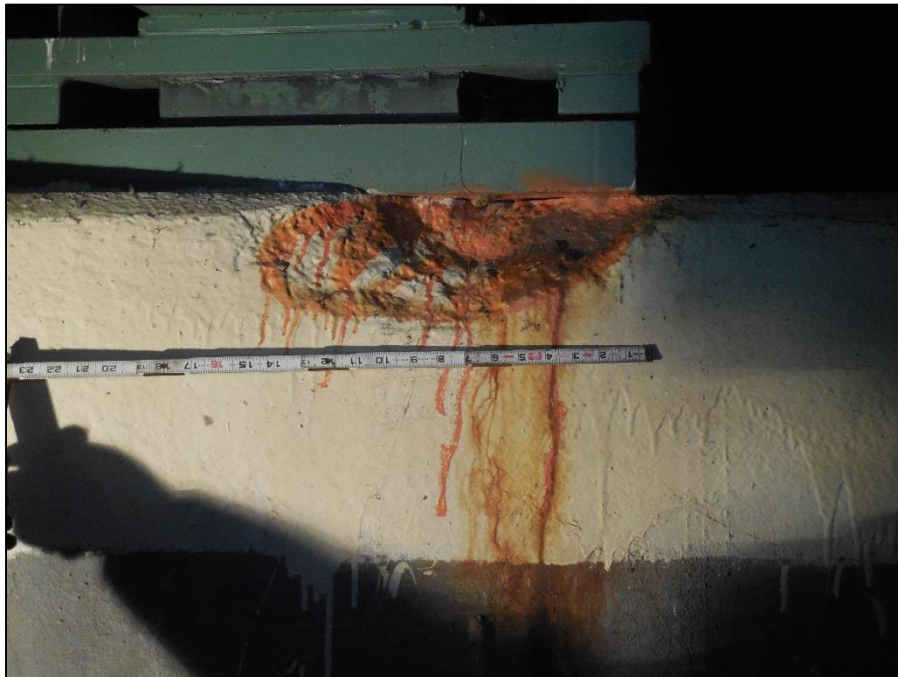
Photo 10: Spall undermining bearing at Span 2, Pier 2, Bearing 4)
